Failure of the Fujinuma Dams during the 2011 Tohoku Earthquake

Daniel Pradel¹, F. ASCE, Joseph Wartman², M. ASCE, and Binod Tiwari³, M. ASCE

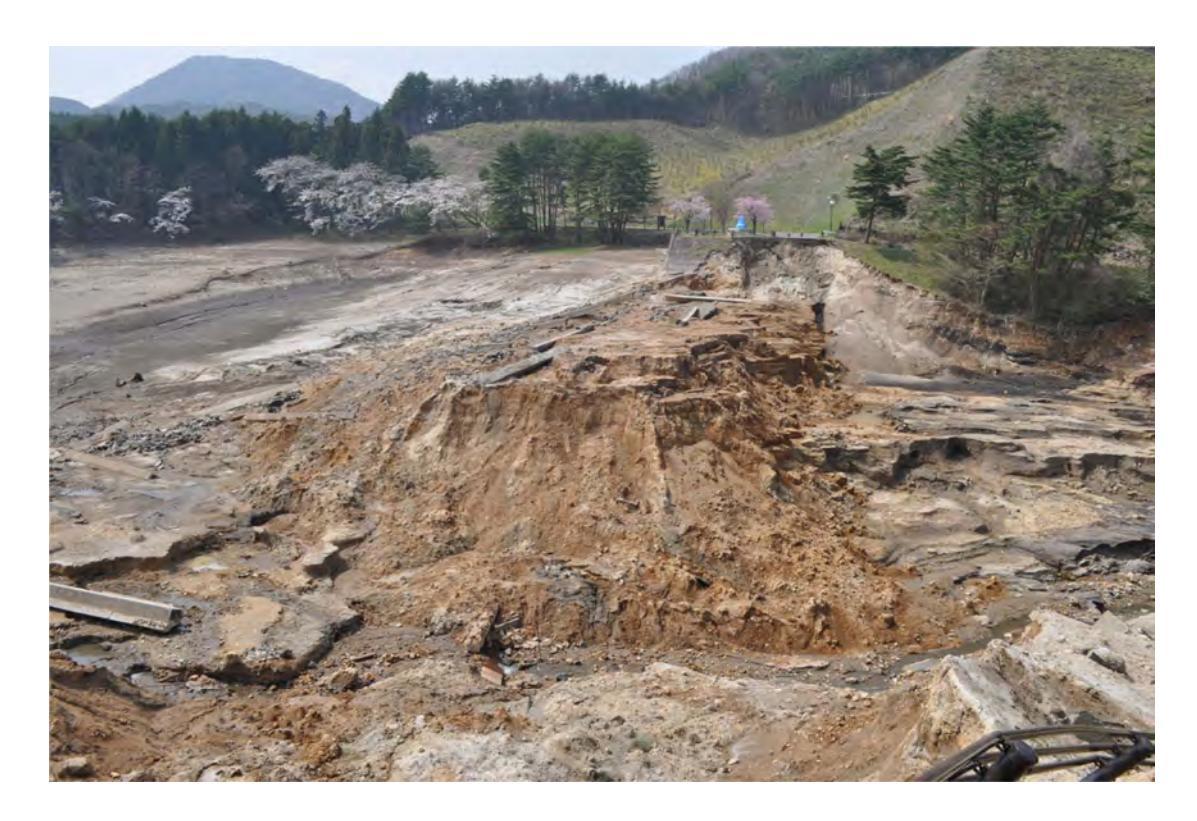
FIG. 1. Photograph of the breached Fujinuma main dam and reservoir.

• The breach exposed a dark layer of residual soil which blanketed the base of the dam and large areas of the left abutment (Figures 1, 4b and 6). This residual soil layer, or paleo-soil, was rich in organics (e.g., roots and even tree trunks) and had been locally reworked into compacted fill along the base of the dam. The location of the paleo-soil layers was geometrically consistent (Figure 4) with the sliding failure mechanism suggested by Figure 5 and previously described above.

sand was observed covering vast areas of the reservoir (Figure 1), portions of the breach zone (Figure 4), and the left abutment (Figure 1). The sand appeared to have been deposited by water during the breach (i.e., post-earthquake) and we did not observe evidence of soil liquefaction (such as sand boils) along the intact portions of the dam and abutments.

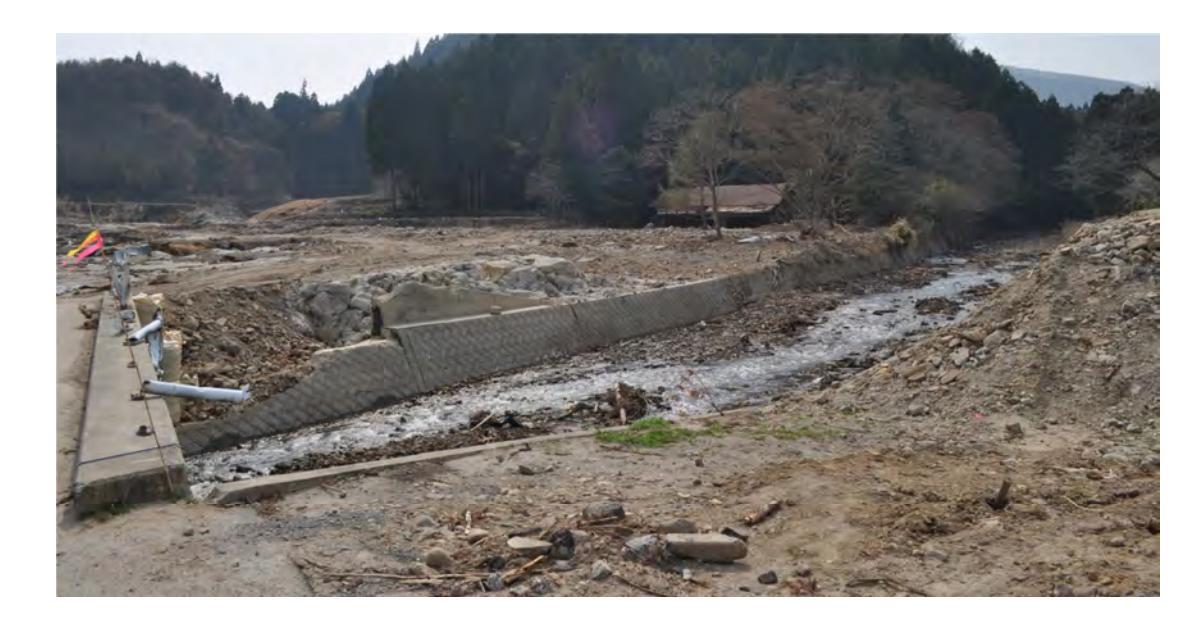
When the earthquake occurred, the reservoir level was almost full; according to a witness, water was seen overflowing the crest 20 to 25 minutes after the earthquake (Matsumoto et al., 2011). A photo in the EERI (2011) report shows almost the entire length of the dam being overtopped approximately 25 minutes after the earthquake. The uncontrolled discharge from the breach of the Fujinuma main dam was channeled through a narrow valley, destroying a small village at the mouth of the valley (Figure 2), and killing 8 people (Towhata et al., 2011).

FIG. 2. Photograph of the flood path downstream of Fujinuma main dam in the village of Naganuma (Fukushima Prefecture).

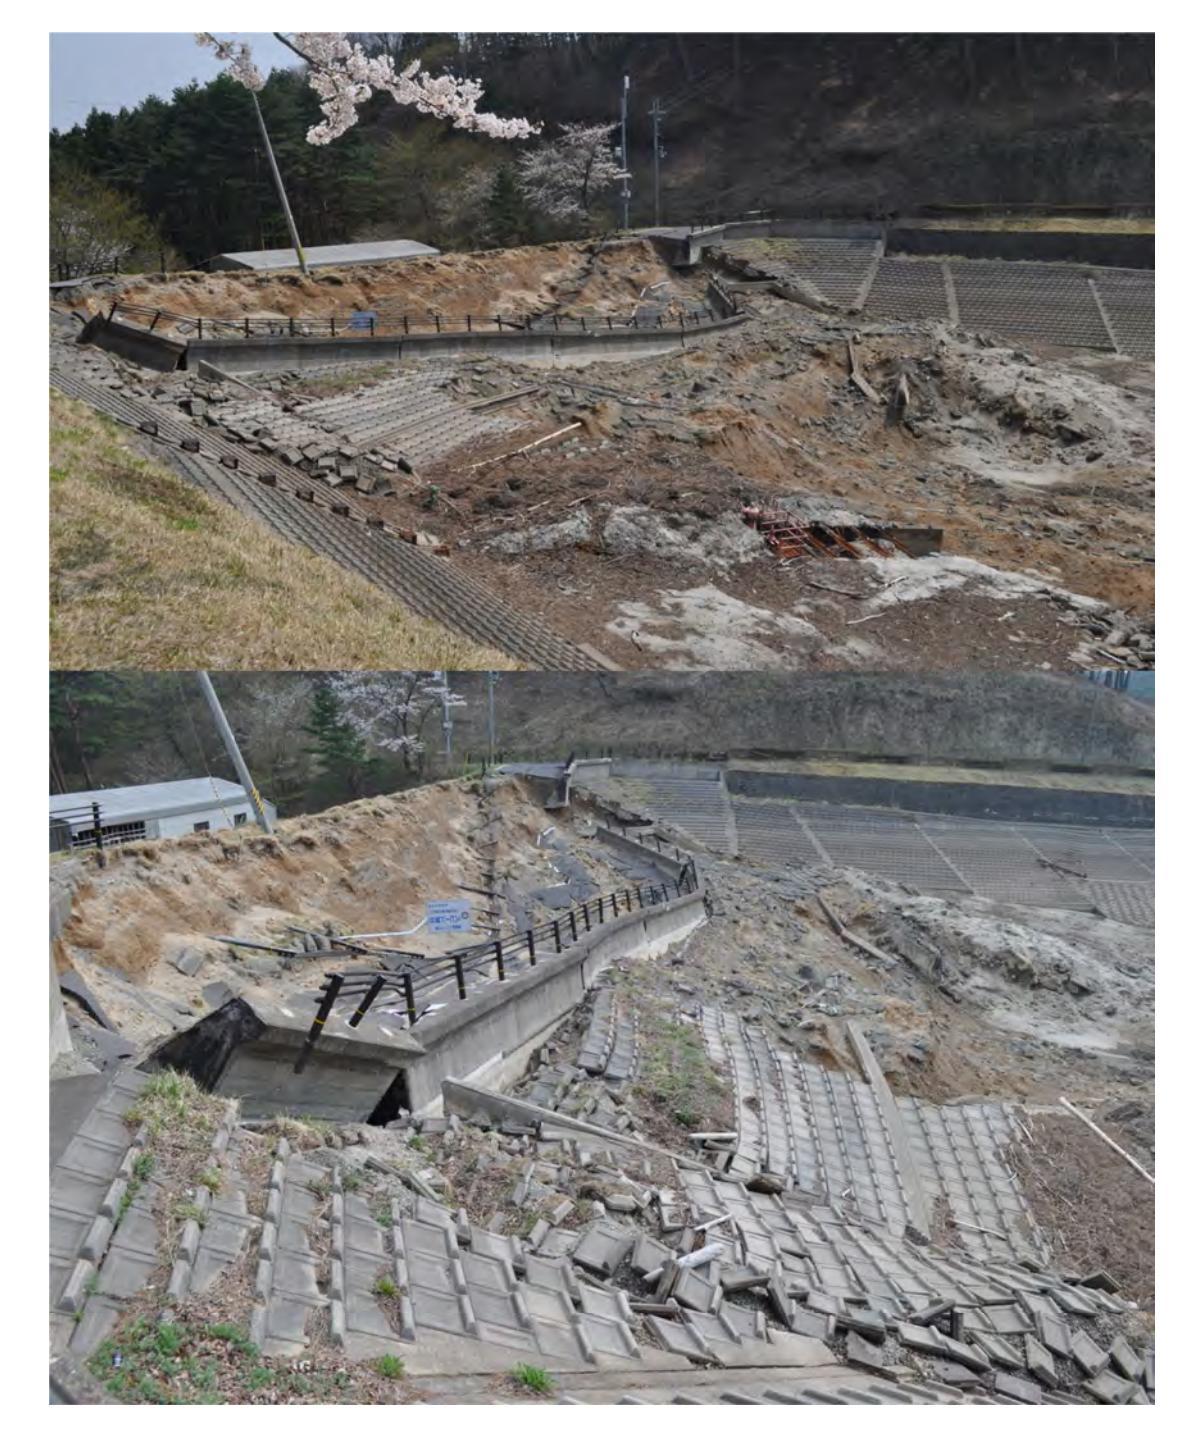
The saddle dam failure is depicted in Figure 3.According to EERI (2011) the saddle dam failure could have been caused by strength loss during the earthquake, i.e., sliding, or by rapid drawdown from the rapid release of the reservoir water through the main dam breach.

FIG. 3. Two photographs of the failed saddle dam of Fujinuma Ike.

Although the failure of the saddle dam is reminiscent of images from the 1971 Lower San Fernando dam liquefaction failure, Figure 3 clearly shows a failure through cohesive materials. These materials appeared similar to those of the main dam which was built during the same period. Furthermore, careful examination by our team of the downstream face of the dam and of the abutments did not reveal evidence of sand boils, lateral spread, or liquefaction related effects.

A LiDAR investigation by Kayen et al. (2011) found little deformation on the slope immediately adjacent to the dam. Hence, our team concluded that the failure was probably due to rapid drawdown, i.e., caused by the sudden release of the reservoir water after the main dam failed.

The main difference between our team's observations and the panel's summary report is that our team did not observe sand rich materials in the upper portions of either the main dam or saddle dam (e.g., Figures 3 and 4a). Please note that sandy materials in the upper portion of the dam are also not reported in Harder et al. (2011), Matsumoto et al. (2011) or JCOLD (2011).

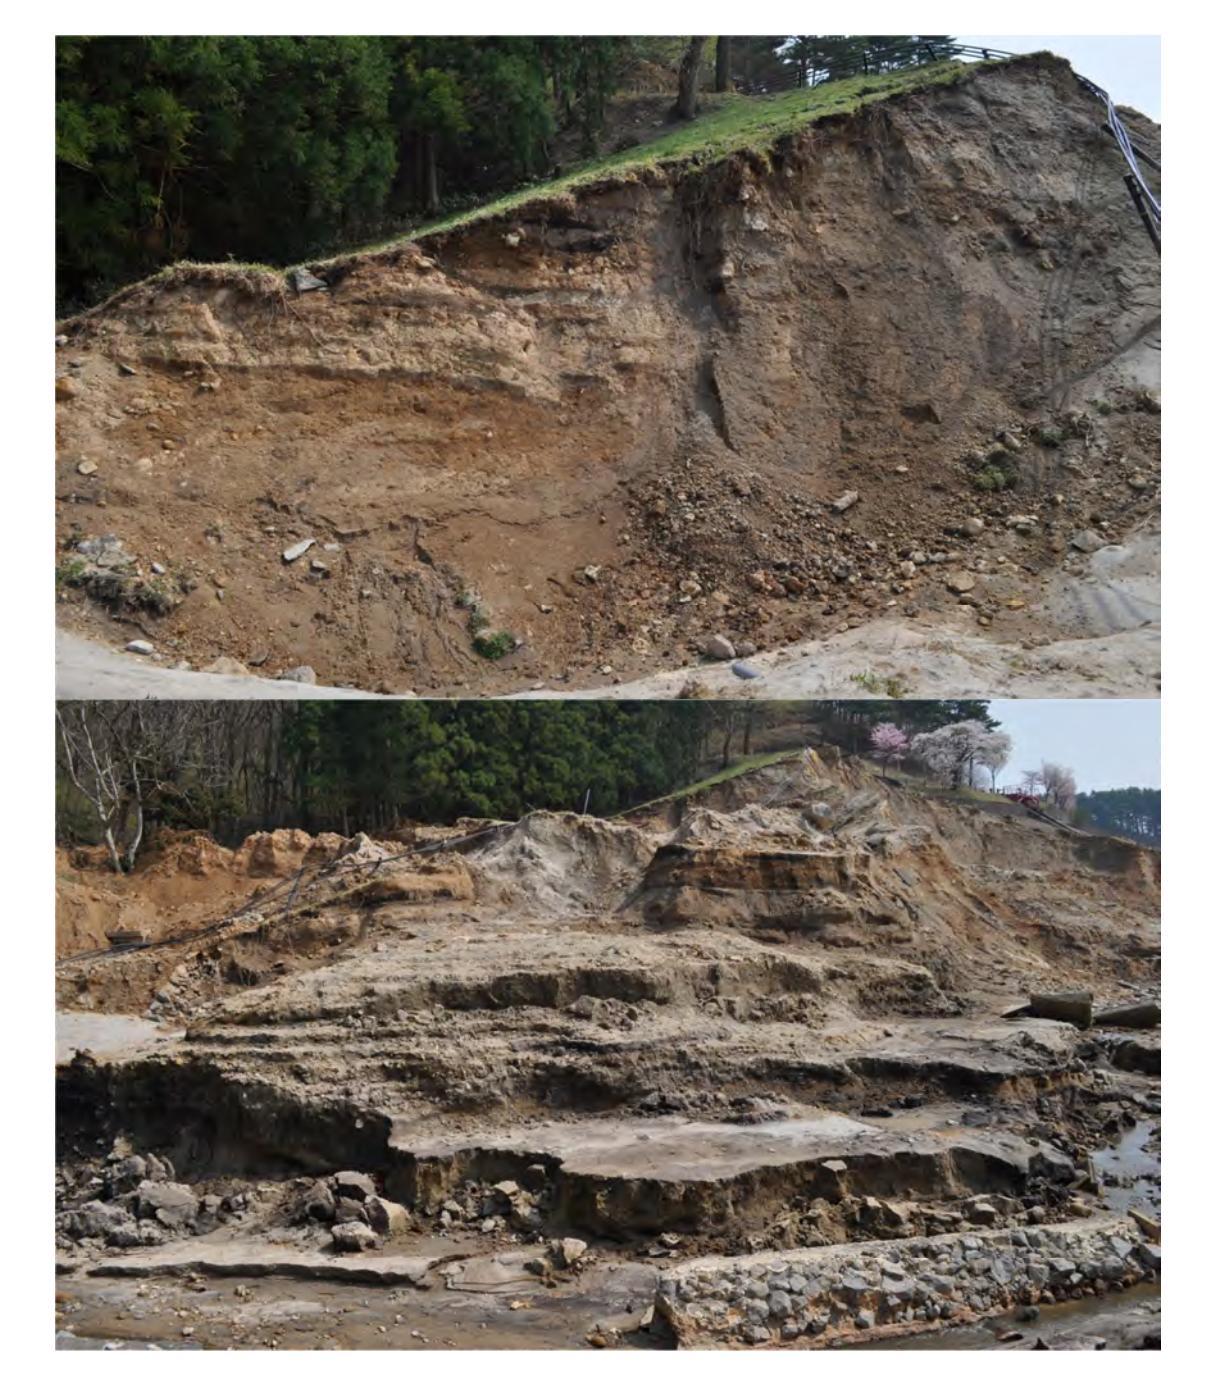
• Along the breached section, nearly vertical exposures up to 5m in height of cohesive fill materials were exposed (Figures 4a and 4b). Evidence of compaction layering was also observed (Figure 4a).

• Along the right abutment large blocks had been displaced and uplifted along the downstream face of the dam (Figures 4b and 5). The position of the blocks indicated several meters of translational movement, i.e., a slope instability.

FIG. 4. Two photographs of the Fujinuma main dam and right abutment.

As seen in Figure 4a, the failure resulted in near vertical sections that exposed compacted fill materials (measured angles ranged from 60° to vertical). Based on the height of the vertical sections we estimated that dam fills had a 20 kPa minimum static undrained shear strength using Taylor charts (Taylor, 1937).

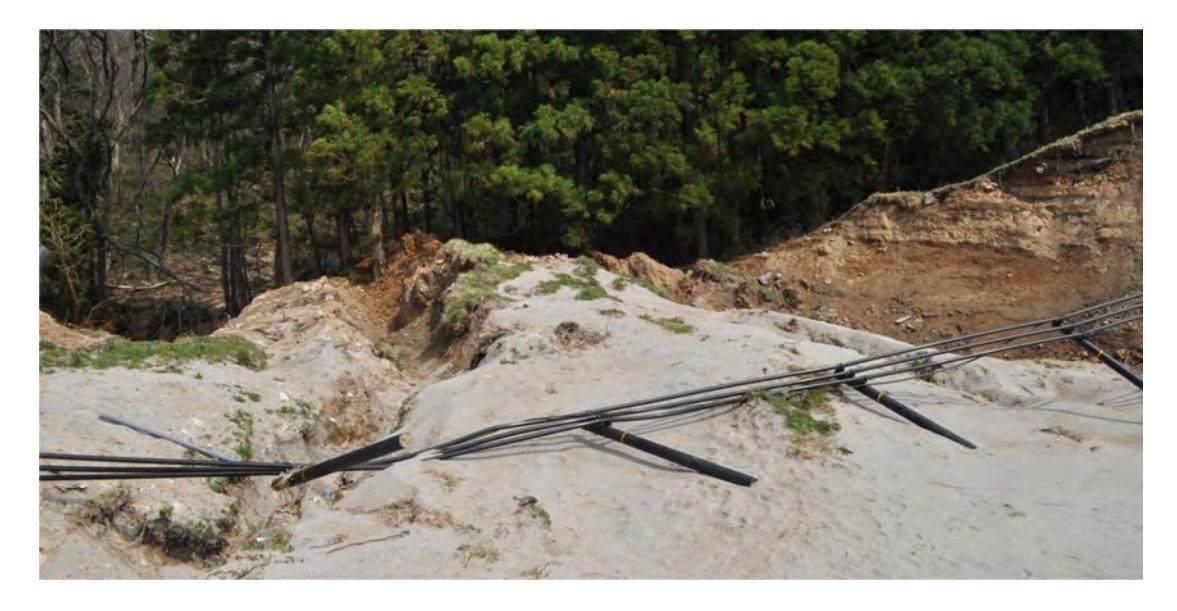
• A thin layer of sand blanketed the displaced blocks of cohesive soils and grass which covered the downstream slope prior to the failure (Figure 5). Similarly,

FIG. 5. Uplifted and displaced blocks along the right abutment of the main dam.

The panel reported that evidence was found for seven types of slides at the location of the main dam. Some are postulated as the overtopping obliterated some of them. Slides labeled No.1 and 2 are directed towards the lake, and slide No.4 is in a downstream direction. It is interesting to note that slide No.4 is shown on both the left and rights abutments. The right abutment portion of slide No.4 coincides with our observations (e.g., Figure 5).

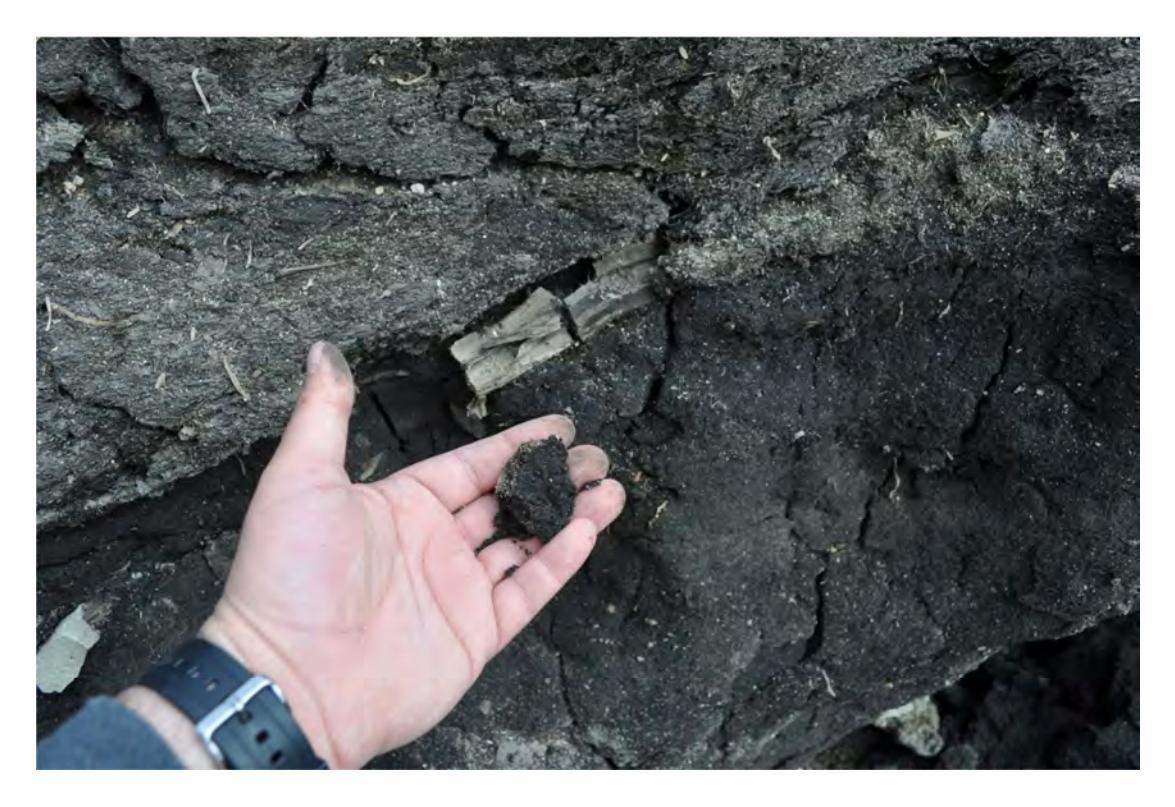
FIG. 6. Organic rich layer of paleo-soil.

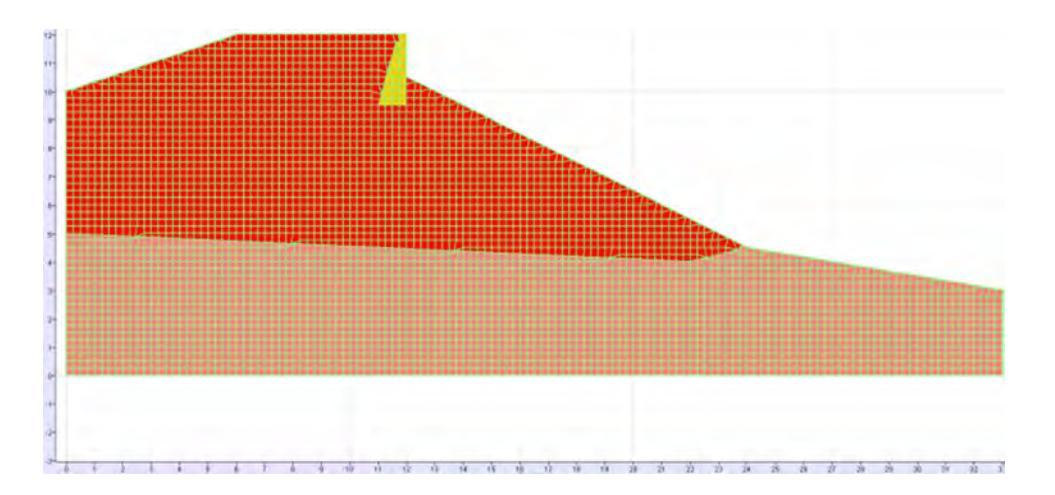
When this minimum static strength was used to analyze the stability of the saddle dam and evaluate the likelihood of the rapid drawdown failure mechanism postulated by our team, we obtained a Factor of Safety of 0.97 by the strength reduction method. The mesh used and the predicted mode of failure are shown in Figures 7 and 8. The predicted failure of the saddle dam is consistent with our field observations and independently supports our strength back-analyses of the near vertical face of the main dam using Taylor charts.

FIG. 7. Mesh used for the stability analyses of the Fujinuma saddle dam.

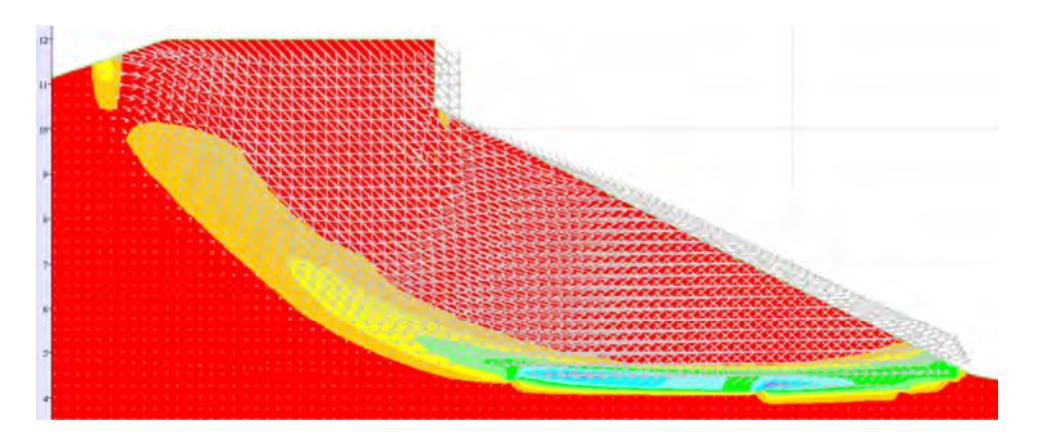
FIG. 8. Mode of failure predicted by the Strength Reduction Method during rapid drawdown (Factor of safety = 0.97); also shown are shear strain contours and displacement vectors.

Our numerical stability analyses also found that using back-calculated undrained shear strengths from the main dam, the similarly constructed Fujinuma saddle dam had a static factor of safety below unity under rapid drawdown conditions. Hence, it was vulnerable to a rapid release of the reservoir water when the main dam was breached, and thus, in our opinion, rapid drawdown was a likely failure mechanism.

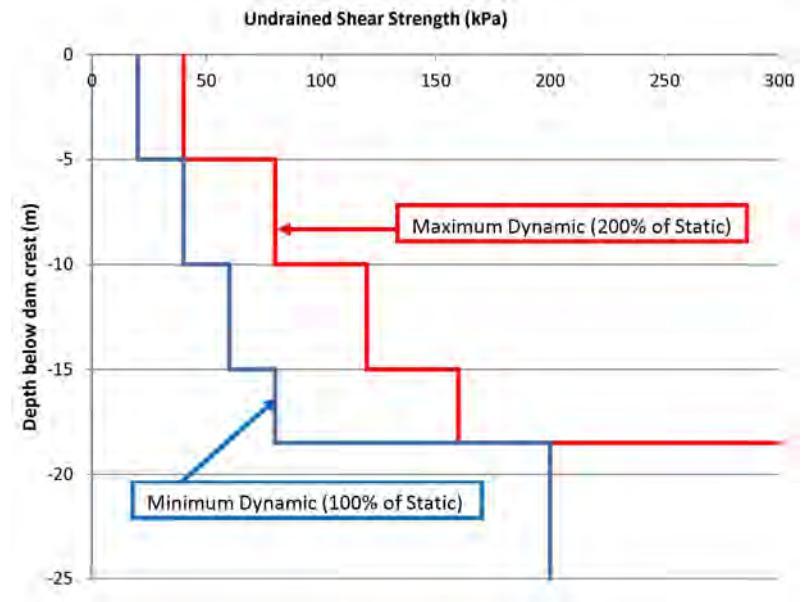
Ishihara (1996) has shown that the dynamic shear strength of cohesive materials, τ_{cyc} , is generally larger than the static strength. At low confining stresses Ishihara's tests on Nanamawari Izu clay showed an increase of up to 100% when subjected to a small number of loading cycles and almost no increase when subjected to a large number of cycles. The shear strengths used in our numerical analyses are consistent with Ishihara's findings (Figure 9).

FIG. 9. Adopted dynamic undrained shear strengths.

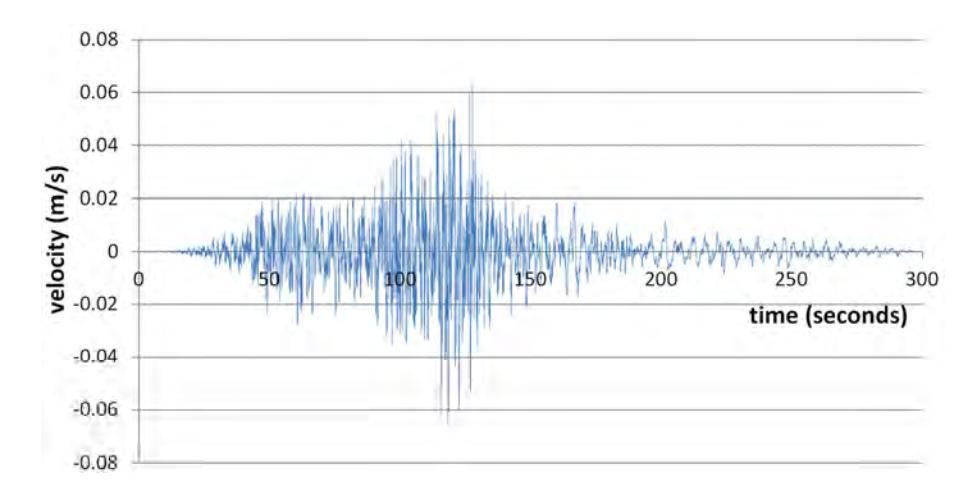
velocity input from FSK015, as shown in Figure 10, served as an input in some of our dynamic runs at the base of our FLAC model. To allow damping to vary with time during the earthquake, we adopted, for simplicity, hysteretic damping using as backbone shear moduli based on the "upper range" curves by Seed & Idriss (1970), and a minor amount of Rayleigh damping (0.1%) was also included. The adopted hysteretic damping used results in the damping curve shown in Figure 11, except when the shear strength of the materials is reached and plastic flow occurs.

FIG. 10. Adopted Velocity input at the base of the numerical model for the FSK025 recording (PGA=0.15g).

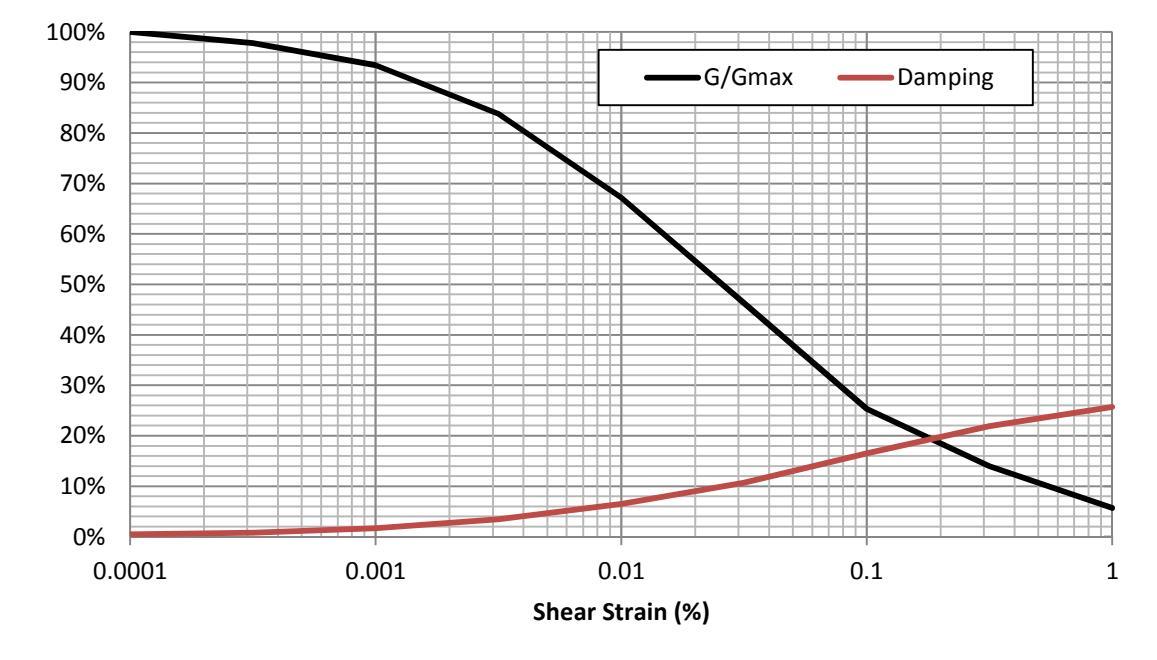
FIG. 11. Modulus reduction and damping ratios from hysteric damping.

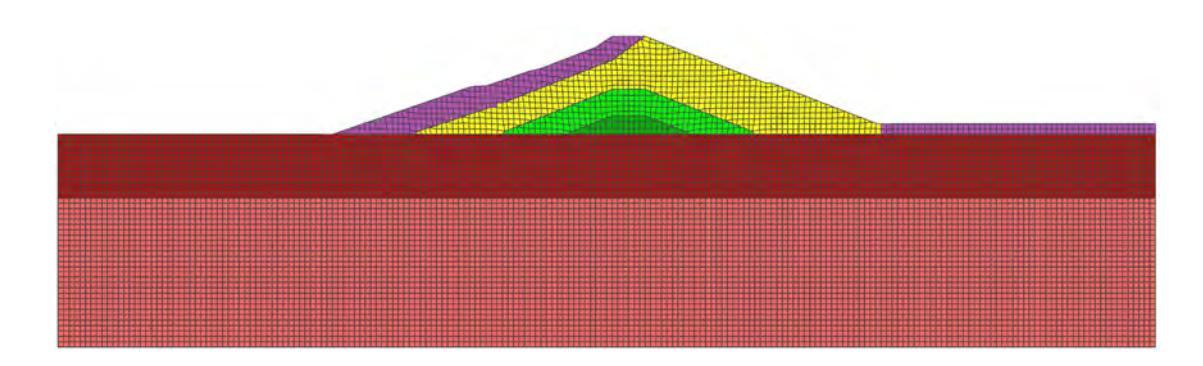
The mesh used in our analyses is shown in Figure 12 with different colors indicating areas of varying shear strengths (Figure 9). As shown in Table 2, large displacements, i.e., failure was predicted for all the analyses using $\tau_{cyc} = S_u$. The predicted mode of failure for all three ground motions was very similar as shown in Figures 13 to 15.

FIG. 12. Mesh used for dynamic analyses (grid base size = 1m x 1m).

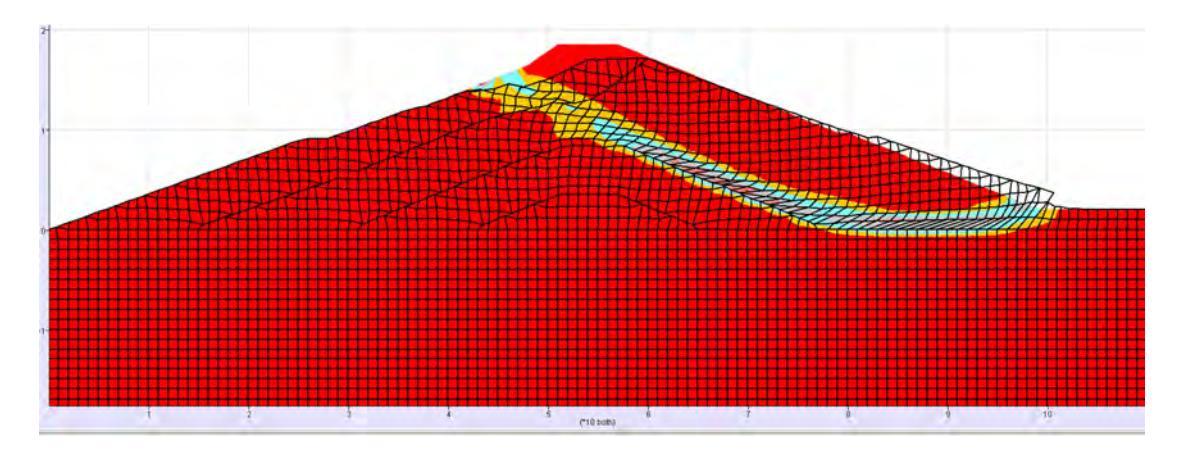
FIG. 14. Predicted mode of failure for FSK025 and $\tau_{cyc} = S_u$.

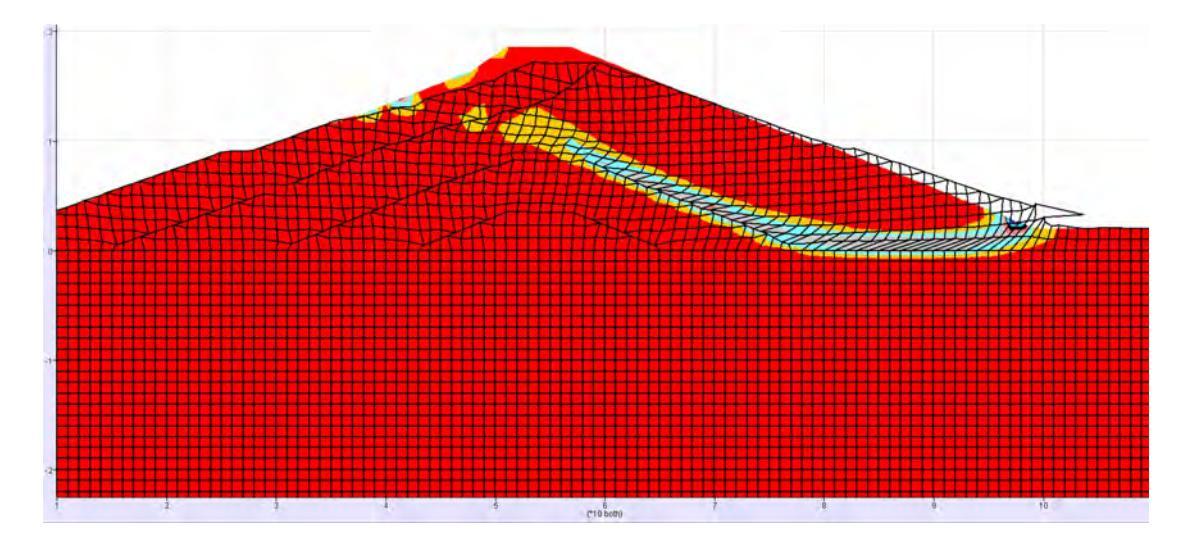
FIG. 15. Predicted mode of failure for TCG001 and τ_{cyc} = S_u
