Failure of the Fujinuma Dams during the 2011 Tohoku Earthquake

Daniel Pradel¹, F. ASCE, Joseph Wartman², M. ASCE, and Binod Tiwari³, M. ASCE

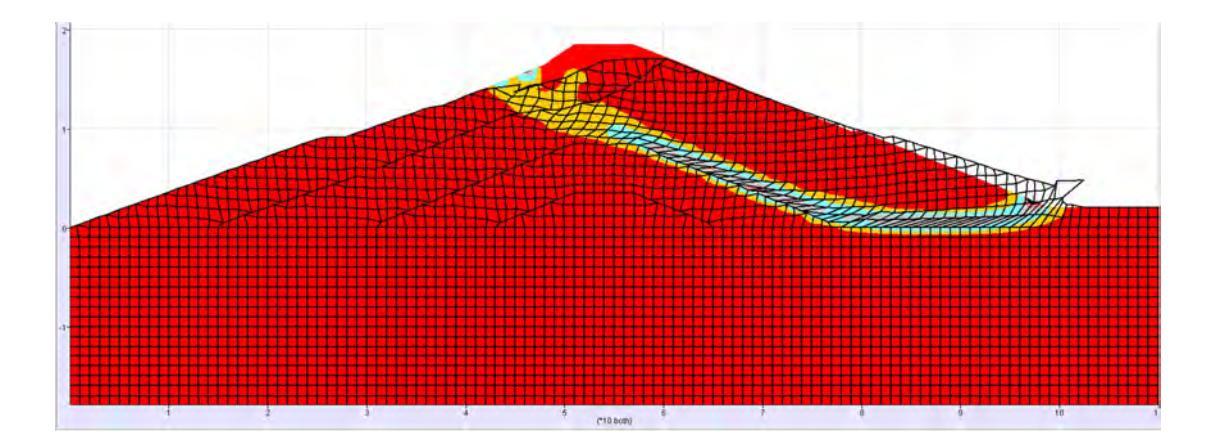
The mesh used in our analyses is shown in Figure 12 with different colors indicating areas of varying shear strengths (Figure 9). As shown in Table 2, large displacements, i.e., failure was predicted for all the analyses using $\tau_{cyc} = S_u$. The predicted mode of failure for all three ground motions was very similar as shown in Figures 13 to 15.
