DAMS AND EARTHQUAKES IN NEW ZEALAND

Peter Amos¹ and Murray Gillon²

ABSTRACT

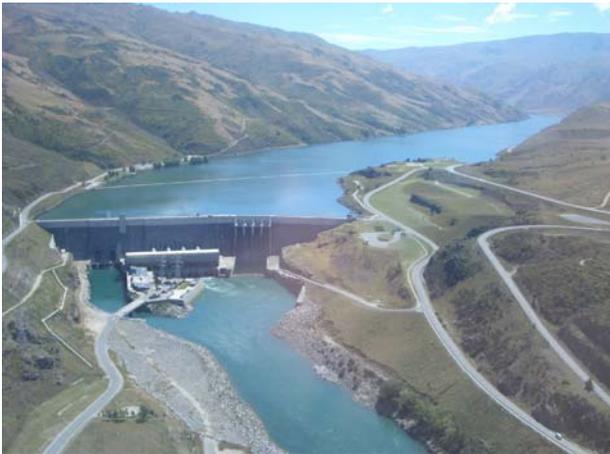
Figure 4a. Clyde Dam
(courtesy Contact Energy)

The Clyde Dam is located on the Clutha River in the South Island of New Zealand. It is a 100m high concrete gravity dam (Figure 4) for hydropower generation. A feature of the dam is the provision of a slip joint to allow up to 2m of movement on the plane of a fault passing through the dam foundation (Hatton et al., 1987a, 1987b).

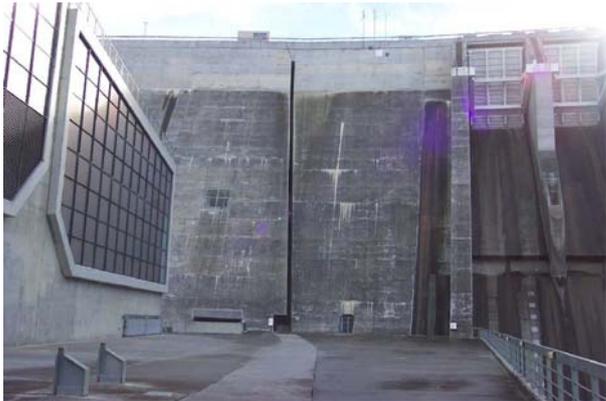
Figure 4b. Clyde Dam slip joint
(courtesy Contact Energy)

The study also identified that a major rupture of the Dunstan Fault could induce up to 200mm of sympathetic movement on a fault in the river channel passing through the dam site. The dam design was modified to provide a slip joint along the fault. The joint was designed to accommodate 2m of strike-slip movement and 1m of dip-slip movement (Figure 5). To keep the joint water tight during normal operation and to limit leakage in the event of fault displacement, a wedge plug has been provided at the upstream face. The joint continues down into a cutoff shaft excavated into the fault below the dam. A blanket of zoned backfill is provided upstream of the dam to control seepage and prevent washout of the fault material should movement occur.

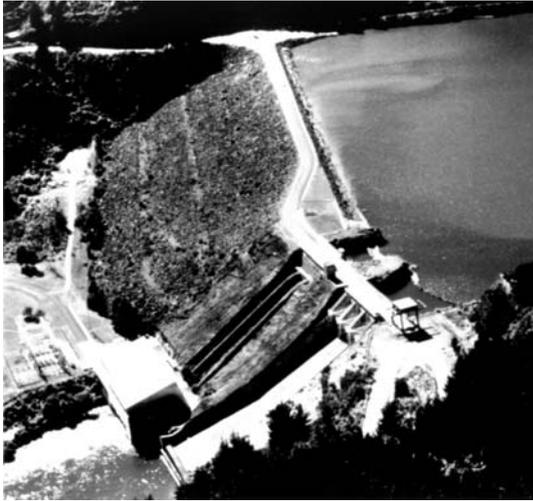
Figure 6. Matahina Dam

Matahina Dam is located on the eastern boundary of the Taupo Volcanic Zone (Figure 2). It is an 80m high rockfill dam (Figure 6) used for hydropower generation. The dam experienced a serious internal erosion incident (not earthquake related) on the right abutment during the initial lake filling in 1967.

The powerhouse and spillway are located on a rock spur (Figure 6) that forms the left abutment. This rock spur has been displaced, primarily by rigid body rotation, over the last 280,000 years. The best estimate of tilting in the SEE was 40-90cm per 100m of block length.

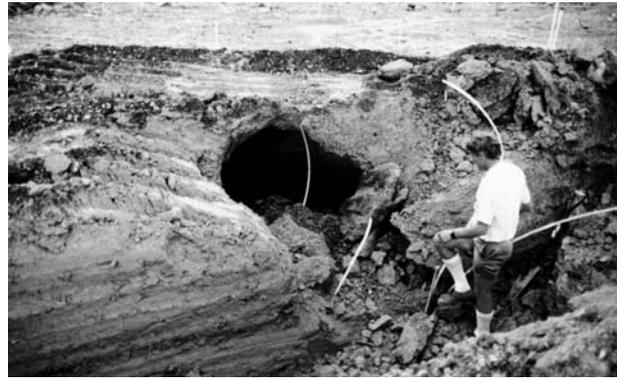
Figure 7. Internal erosion in the dam core

On 2 March 1987 it was subject to peak ground accelerations of 0.33g from a nearby magnitude (M_L) 6.3 earthquake. Subsequent investigation (Gillon, 1988) revealed internal erosion damage at the left abutment and in December 1987, while the damage was being assessed, an erosion cavity formed on the crest above the damaged area. Following an emergency drawdown of the reservoir, excavation revealed serious damage to the core (Figure 7) and major repairs were undertaken (Gillon and Newton, 1991). This internal erosion incident at the dam has recently been re-evaluated (Gillon, 2007 in press).

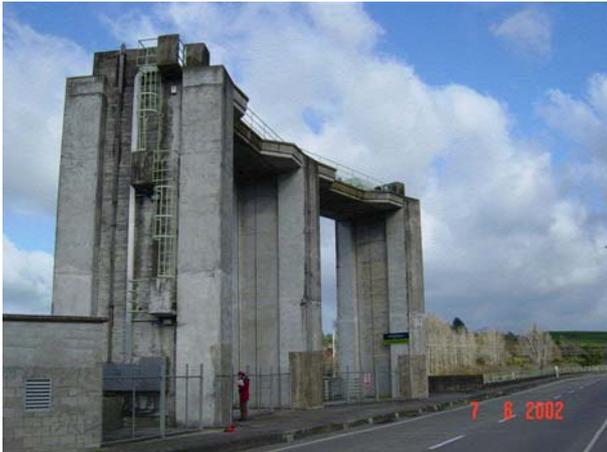
Figure 19. Whakamaru Dam strengthened spillway columns

At the Roxburgh, Ohakuri and Whakamaru Dams, all built in the 1950's, the spillway superstructure has been upgraded to ensure the seismic safety and post-earthquake operability of the spillways. At Whakamaru the gates are operated using winches mounted 12m above the dam deck on a reinforced concrete frame (Foster et al., 2003). The amplification effect of earthquake loads at the level of the winches was estimated to be 12 times the dam foundation accelerations. These columns were strengthened by adding reinforced concrete to change the former rectangular section into an I beam section as shown in Figure 19. A similar upgrade took place at Ohakuri Dam.

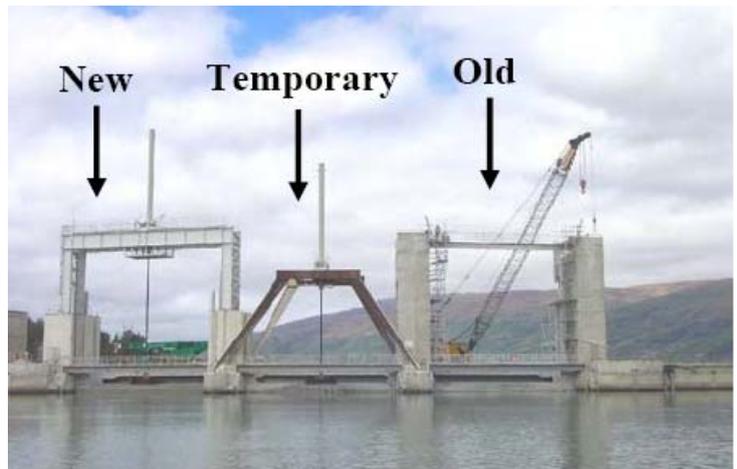
Figure 20. Roxburgh Dam spillway gantry upgrading

The Roxburgh Dam was built with a similar reinforced concrete spillway superstructure as at Whakamaru Dam. Upgrading in this case consisted of spillway bridge deck strengthening to limit the displacement of spillway piers followed by progressive demolition of the superstructure and its replacement with a steel gantry. Hydraulic lifting cylinders replace the former winches and counterweights. In order to maintain sufficient spillway capacity during the work, a temporary lifting frame was installed on the centre gate. Figure 20 shows the work in progress. At both dams the spillway gates have also been strengthened and the former diversion sluices have been modified to operable low level outlets.
